DAF Planet/Flat-Top Building: Summary of Unexpected Airborne Radioactivity on Low-Volume Air Samples Due to Ventilation Lineup

# NATIONAL CRITICALITY EXPERIMENTS RESEARCH CENTER NCERC

DAF Planet/Flat-Top Building: Summary of Unexpected Airborne Radioactivity on Low-Volume Air Samples Due to Ventilation Lineup Changes

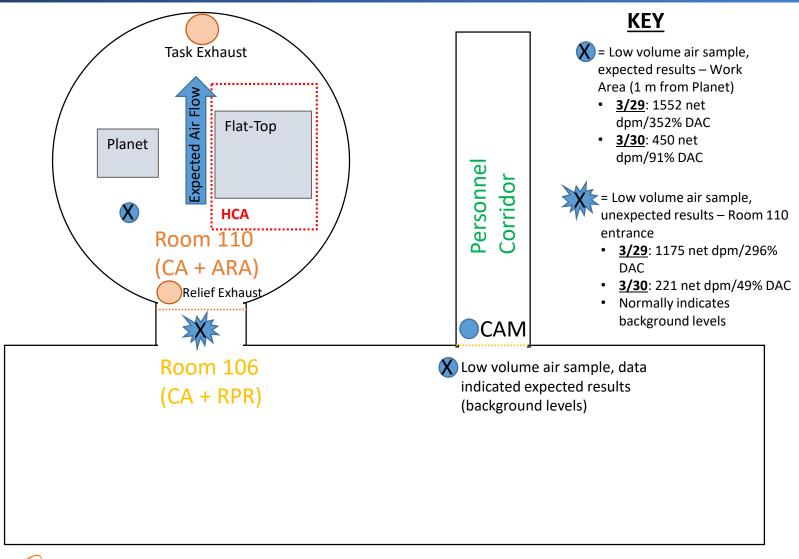
## **Data Visual**

- The RCT supervisor analyzed data collected during the Planet MUSIC experiment on 3/29/21 and 3/30/21. The data indicated unexpected airborne radioactivity at the mouth of the round room. The RCT Supervisor also observed the task exhaust was running at a lower volume than normal.
- No contamination was detected on area survey swipes, no suspension limits were exceeded, and the CAM did not alarm.
- The RCT supervisor notified the DAF NOM and NCERC FOD. An administrative hold was placed on the building.

Subsequent discussion revealed that multiple ventilation lineup changes, which caused the anomalous condition, were conducted without notifying RadCon or secondary REOP holders of the change.

**Short Term Solution:** NOM approval is now required for any changes to ventilation lineup. Task Exhaust Fan is set at 2000 cfm (maximum setting). **Long Term Solution:** New velocity transmitters have been ordered and are expected to be installed by the end of April.
